In Situ Inspection for Generator Retaining Rings of Geothermal Power Plant 60 MW

Imam Djunaedi and Hilman Syaeful Alam

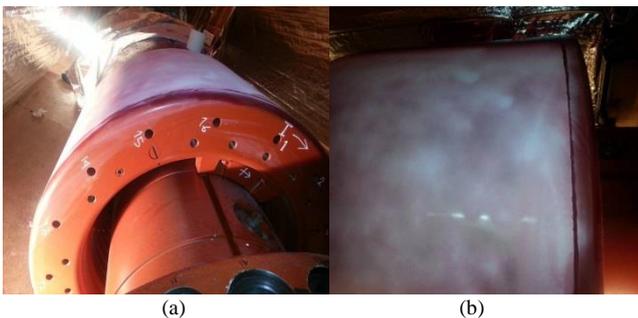
Fig. 7. PT inspection results for (a) exciter side and (b) generator side.

The penetrant testing (PT) refers to non fluorescent or solvent removable method. It was done by applying a dye penetrant on the surface of retaining ring at 5 minutes of dwell time. The developer is used to describe the profile of defects on the material. In this study, it is used the SKL-SP type of penetrant from Magnaflux with SKD-2 developer type and SKC-S remover type. Based on this inspection, it was not detected the presence of defects on both sides of the retaining ring generator. Fig. 7 shows the PT inspection result of the retaining ring for turbine and exciter side.

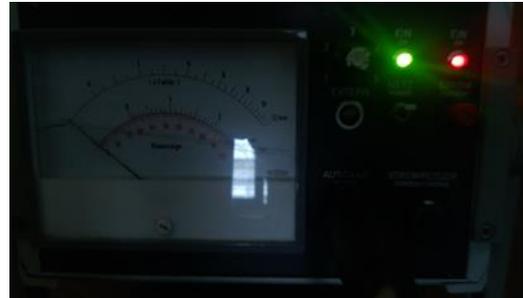
Although based on the PT inspection result is not found of possibility of defect or crack on the retaining ring, however the crack depth testing is performed at several locations that suspected of having crack. In this study, the analog crack depth meter is used to evaluate the depth of crack on the retaining ring. Fig. 8 shows the display of analog crack depth meter. Based on this inspection, there is no find any crack on both sides of the retaining ring.

Fig. 8. The display of analog crack depth meter.

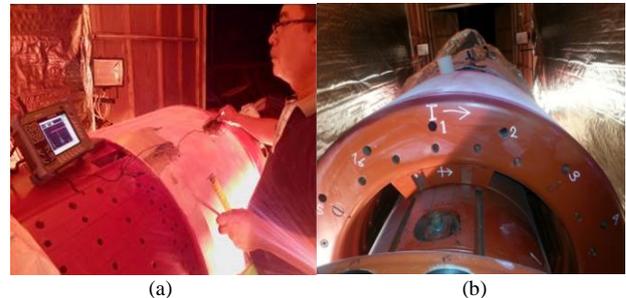
The possibility of defect at the shrink fit area and the inner surface of the retaining ring is detected using Ultrasonic Testing (UT). In this study, it uses Krautkramer ultrasonic flaw detector type Epoch 600 with the probe straight beam 0° and the couplant type grease. Fig. 9(a) shows the UT inspection on the retaining ring. The inspection was applied on the entire of retaining ring in circumferential direction up to 360 degrees with numbering identity on both side i.e. exciter side and turbine side, see Fig. 9(b). Based on the inspection using UT, there is no detected anomaly the shrink fit area and the inner surface of the retaining ring.

Fig. 9. (a) The UT inspection and (b) numbering identity at circumferential direction.
