The Reason Analysis of Holland Blackout on March 27, 2015 and Lessons for Hunan Power Grid

Meng Xiang, Dongzhen Yu, Wenlin Wang, Jian Zuo, Yangwu Shen, and Xiaoqian Xie

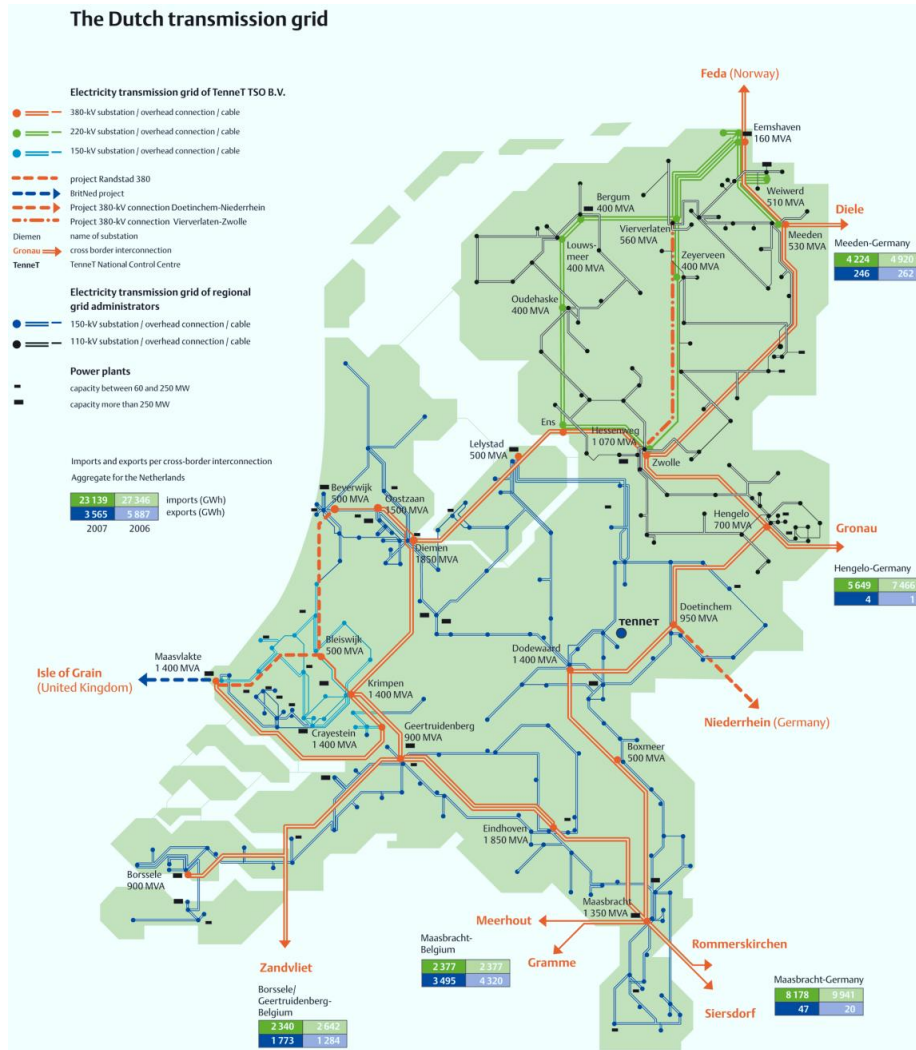
Fig. 1. The Dutch transmission grid.

From Fig. 1 it appears that Noord-Holland (include Amsterdam and other important loads) is just powered by two 380kV substation, Diemen and Oostzaan (Beverwijk is powered by Oostzaan). On the one hand, Diemen’s complete failure is likely to result in the overload of Oostzaan-Krimpen transmission lines or the overload trip in Oostzaan substation, and Noord-Holland will lose all 380kV power. Because of the less power supply access to the

150kV grid in Noord-Holland, It is almost certain that there will be a large area blackout in the Noord-Holland area. On the other hand, because Flevoland is powered by Lelystad substation which is connected to Diemen, if Diemen fails, the power supply of Flevoland will be affected, causing power cuts in part of Flevoland.

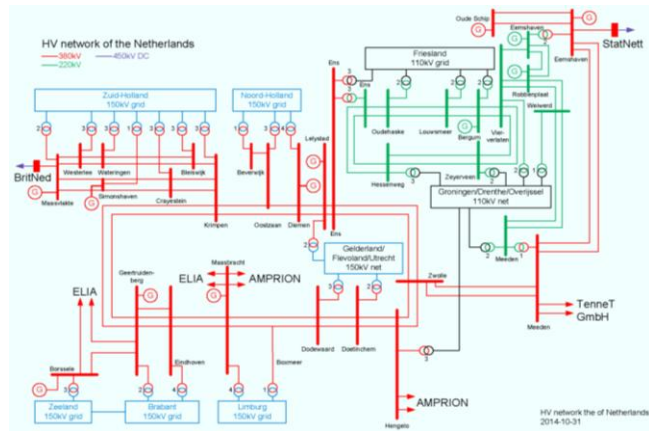
Fig. 2. High voltage network of the Netherlands.

From Fig. 2 we can see, Amsterdam and other important load are powered only by two 380kV substation (Diemen and Oostzaan) with few 380kV power supply, this blackout happened on account of the line overload due to Diemen exiting flow transferring. In order to weaken the dependence of Randstad and other regions on Diemen, Tenne T has begun to build the Randstad 380 kV Northern Ring connection in 2007, which will be completed in 2018 in prediction. If the complete failure happens in Diemen again, this "strong grid" will reduce the damage to northern areas.
