In Situ Inspection for Generator Retaining Rings of Geothermal Power Plant 60 MW

Imam Djunaedi and Hilman Syaeful Alam

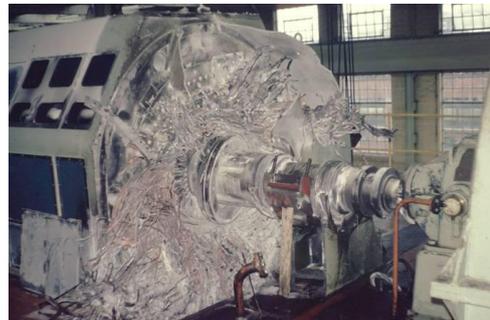
Fig. 2. Generator retaining ring failure [1].

In the case of generator retaining rings, fretting can develop at shrink fit and mating surfaces and at winding support positions. It can also suffer damage caused by torsional vibration. Fretting fatigue initiated crack that propagated during torsional interaction of the shaft [10]. The high levels of residual stress from the cold working process and further loads which are imposed by shrink fitting, self-weight and copper support loads during operation can lead to service failure. The service failures on the retaining ring are known to result in catastrophic failure of the generator and part of its associated turbine or prime mover. It is possible for these rings to rupture or “explode” damaging the stator end winding, rotor winding and end cover that is shown in Fig. 2 [1].
